HERON ROAD BRIDGE (A)

On August 10, 1966 one of the spans of the Heron Road Bridge in Ottawa collapsed during pouring of the deck, carrying nine persons to their deaths and causing injury to many others. This case presents the story of the collapse and the subsequent investigation as recorded in the press and trade journals. This case focuses on engineering aspects of the tragedy and many human interest aspects have had to be omitted. It is hoped that the lessons to be drawn from this case will help prevent future tragedies of this kind.

Report on the Heron Road Bridge Failure

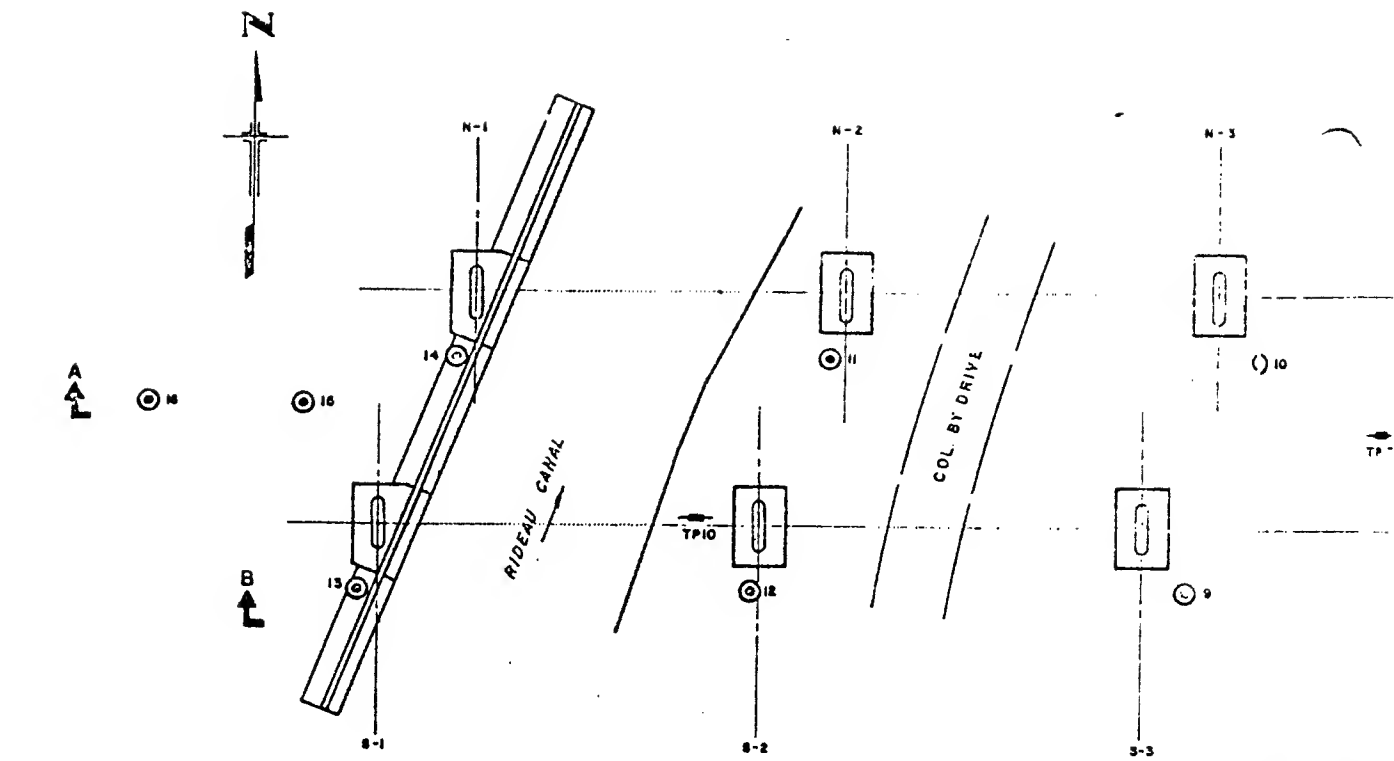
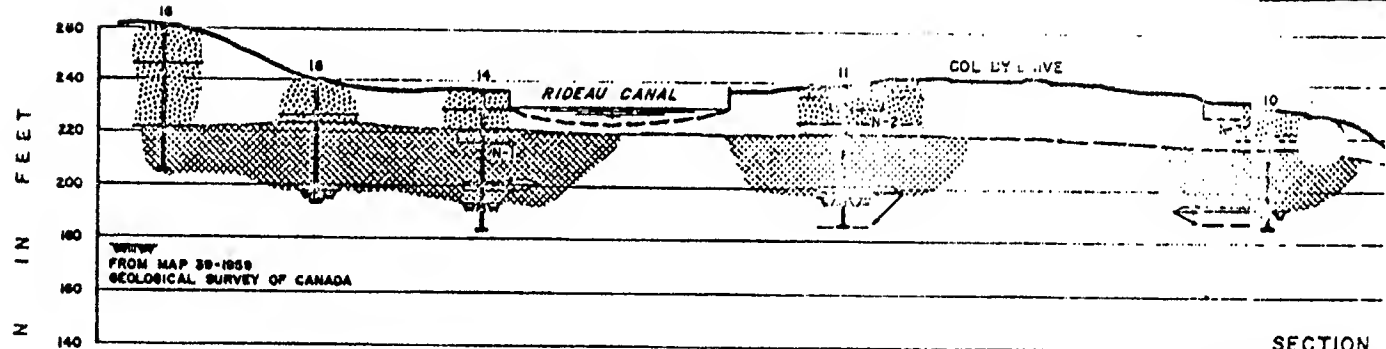
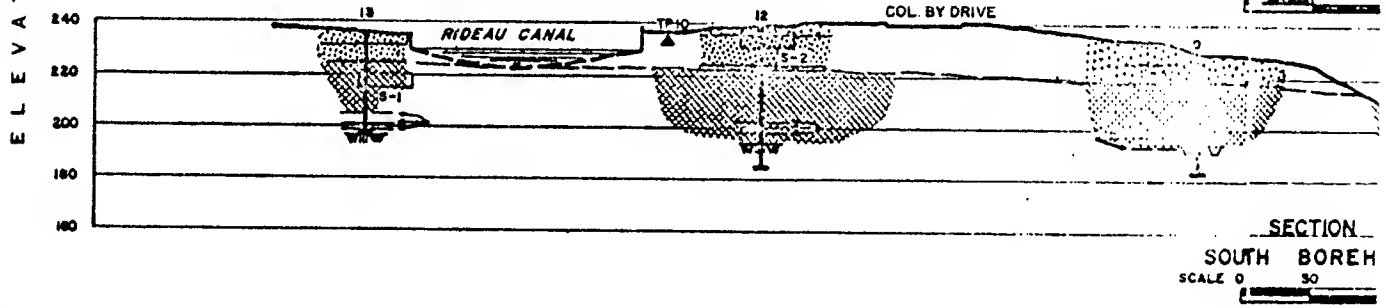
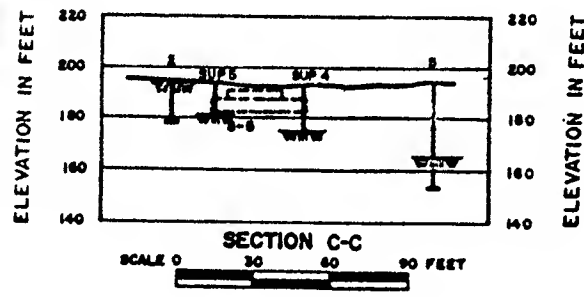
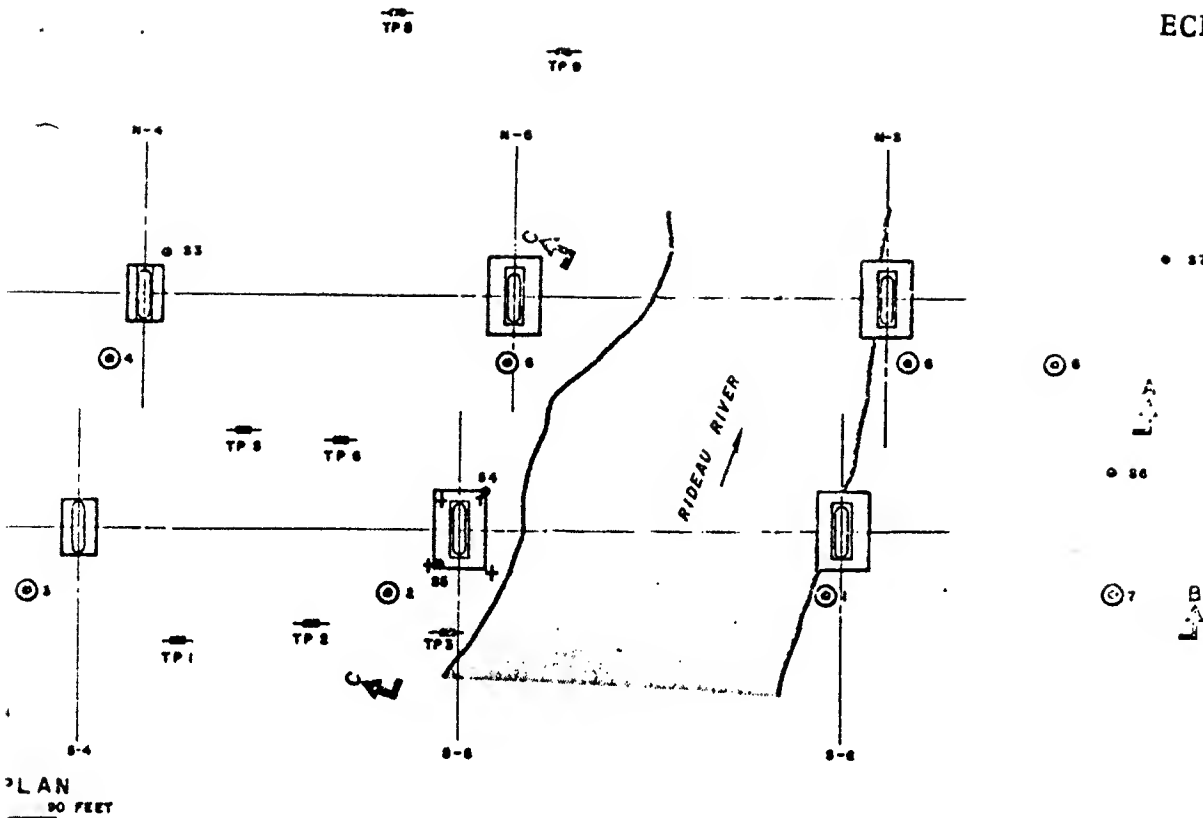
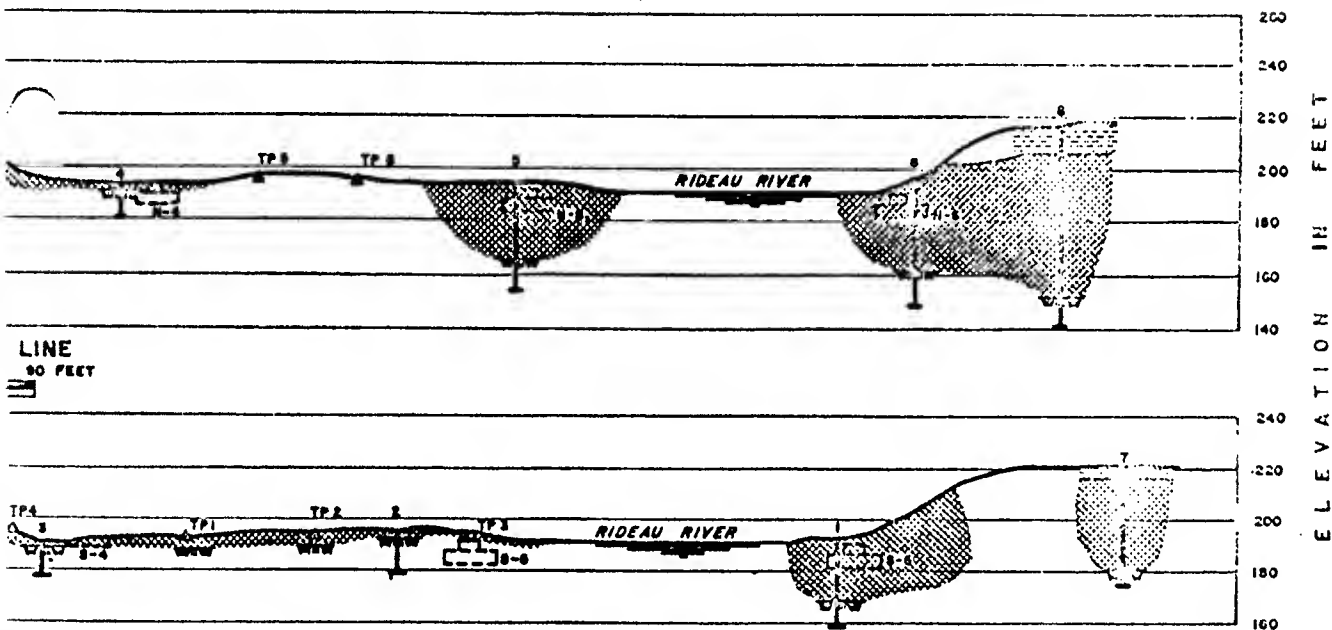
1. PLAN, PROFILE AND BOREHOLE DATA FROM DILLON, JOB 9821-1 DRAWINGS F-2, 3, 4.
2. TEST PIT DATA BY ACRES PERSONNEL
3. SILT IN HOLES 7 AND 8 CONTAIN ORGANIC TRACES
4. TWO TO FOUR FEET THICK LAYER OF MEDIUM TO STIFF CLAY WITH COBBLE SKELETON WAS DETECTED EAST OF PIER 55, AND NORTH EAST OF PIER 58.
5. CONTRACTOR PLACED TWO FEET OF COMPACTED CLAY FILL EAST OF PIER 55
6. RIVER BANKS SHOWN IN LOCATIONS PRIOR TO CONTRACTORS OPERATIONS
